## **STRUCTURE STUDIES OF POROUS OXIDE LAYERS FORMED ON 13CrMo4-5 STEELS LONG-TERM OPERATED IN THE POWER INDUSTRY**

***Monika Gwoździk***

The paper contains results of studies on the formation of oxide layers on 13CrMo4-5 steel long-term operated at an elevated temperature. The material studied comprised specimens of 13CrMo4-5 steel operated at the temperature of 455°C during 130,000 hours (steel 1) and 540°C during 120,000 hours (steel 2). The oxide layer was studied on a surface and a cross-section at the outer surface of the tube wall. The paper contains results of studies of porosity in the oxide layer. The oxide layer formed on the studied steel 1 is ~146 µm thick, while on the steel 2 ~248 µm. It has been found that steel 2 has higher porosity.

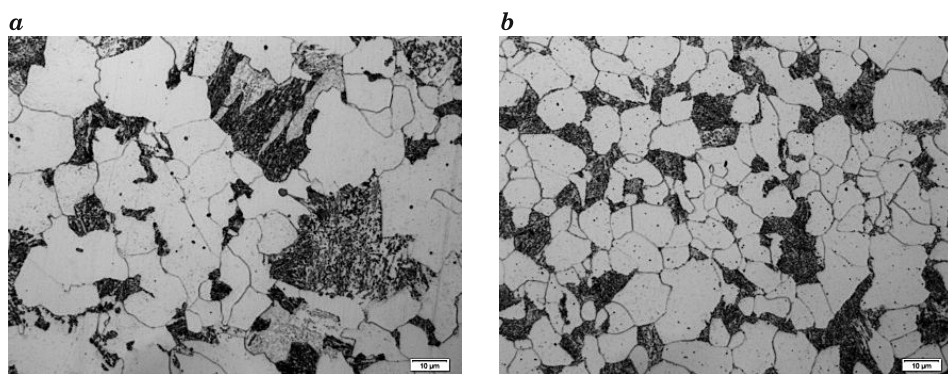
Steels 1 and 2 have the same structure, which is ferrite, perlite and bainite (Fig. 2). For steel 1 it was observed that the size of the grain is diversified and the elements of the structure are unequally placed. In addition, in this steel there are sporadic sulphide precipitates which occur both inside and on the grain boundaries (Fig. 2a). The structure of steel 2 is characterized by a large amount of carbide precipitates both inside and on the grain boundaries. The carbides which occur on the grain boundaries create so-called “chains” (Fig. 2b).

Fig. 2. Microstructure of 13CrMo4-5 steel, LM, 1000x: *a* – steel 1, *b* – steel 2

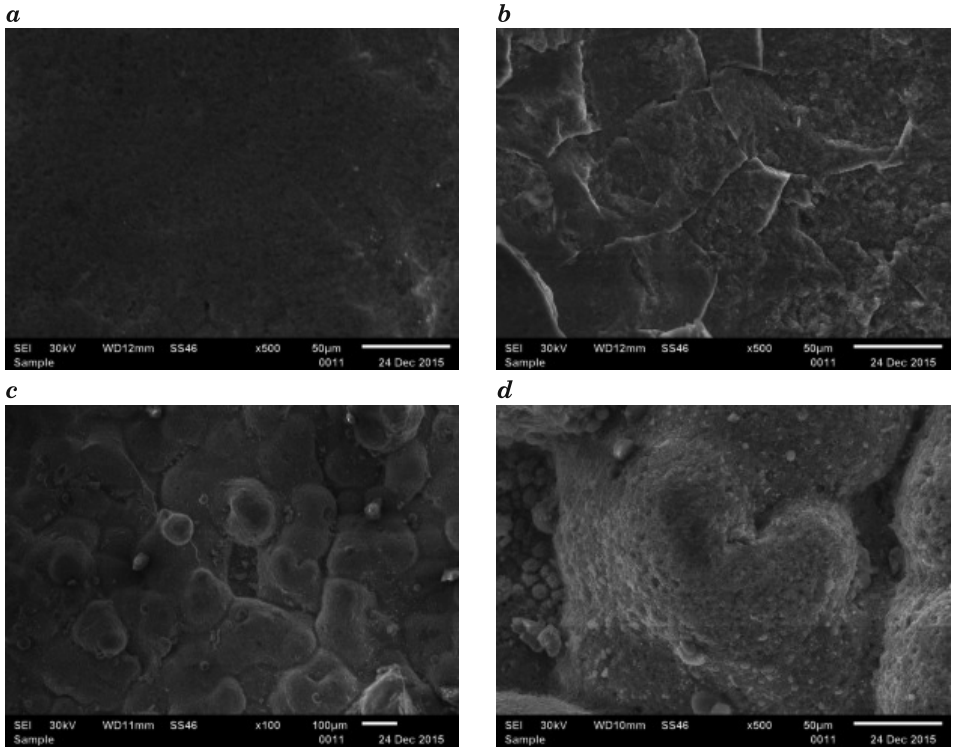
Observations of the oxide layer surface by means of scanning electron microscopy have shown that in the case of steel 1 there are oxide areas without damage, presented in Fig. 4a. In turn, Fig. 4b presents a damaged oxide layer from the same steel. Damaged areas of the layer, which are crystalline in nature, are visible. Figs. 4c and d present the oxide surface formed on steel 2. A significant surface development may be observed on this steel. Also deposits exist, apart from the oxide layer, confirmed by the EDS analysis (Fig. 5).

Fig. 4. Oxides formed on 13CrMo4-5 steel, outer surface, SEM: *a, b* – steel 1, 500x, *c* – steel 2, 100x, *d* – steel 2, 500x

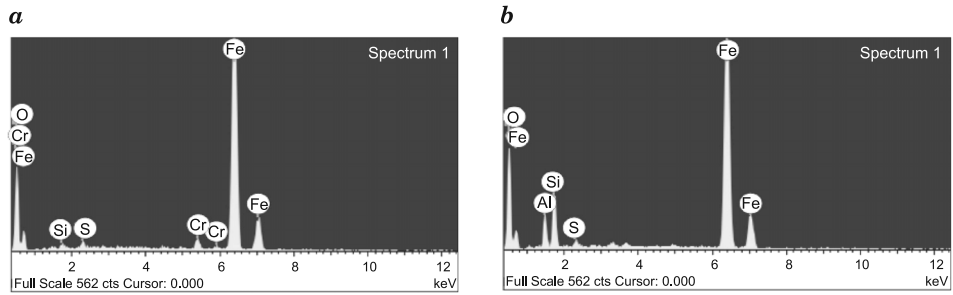
Performed XRD measurements (Fig. 6) have shown that in both cases (steel 1 and 2) the oxide layer is built of hematite ( $\text{Fe}_2\text{O}_3$ ) and magnetite ( $\text{Fe}_3\text{O}_4$ ). Moreover, the EDS analysis in both cases have shown the existence of Si and additionally – for steel 2 – of Al. These elements form such compounds as  $\text{SiO}_2$  and  $\text{Al}_2\text{O}_3$ , which are components of hard coal ashes.

Fig. 5. SEM / EDS: *a* – steel 1, *b* – steel 2

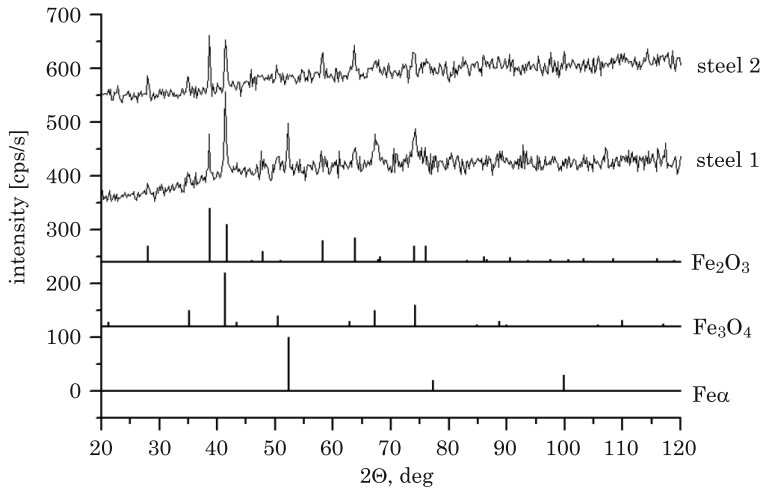
Fig. 6. X-ray diffraction patterns from the oxides layer obtained by means of XRD technique

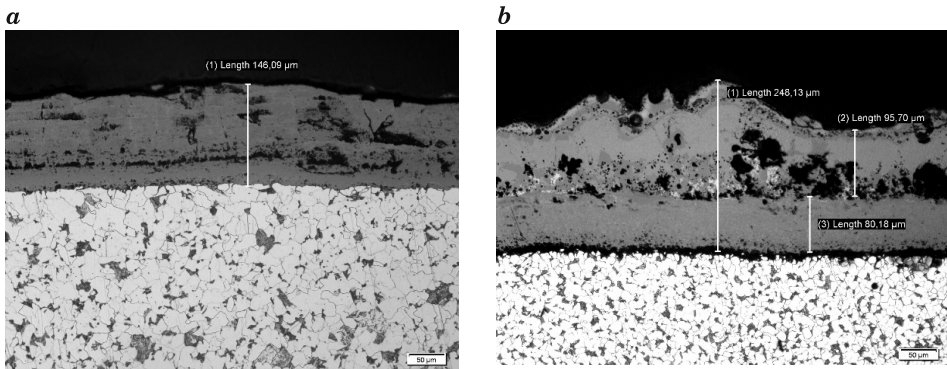
Observations of metallographic microsections made on a cross-section have shown that for steel 1 the oxide layer was  $\sim 146 \mu\text{m}$  thick (Fig. 7a), while for steel 2 it was  $100 \mu\text{m}$  thicker and was  $\sim 248 \mu\text{m}$  (Fig. 7b).

Fig. 7. The thickness of oxide layer formed on the steel examined, LM, 200x: *a* – steel 1, *b* – steel 2

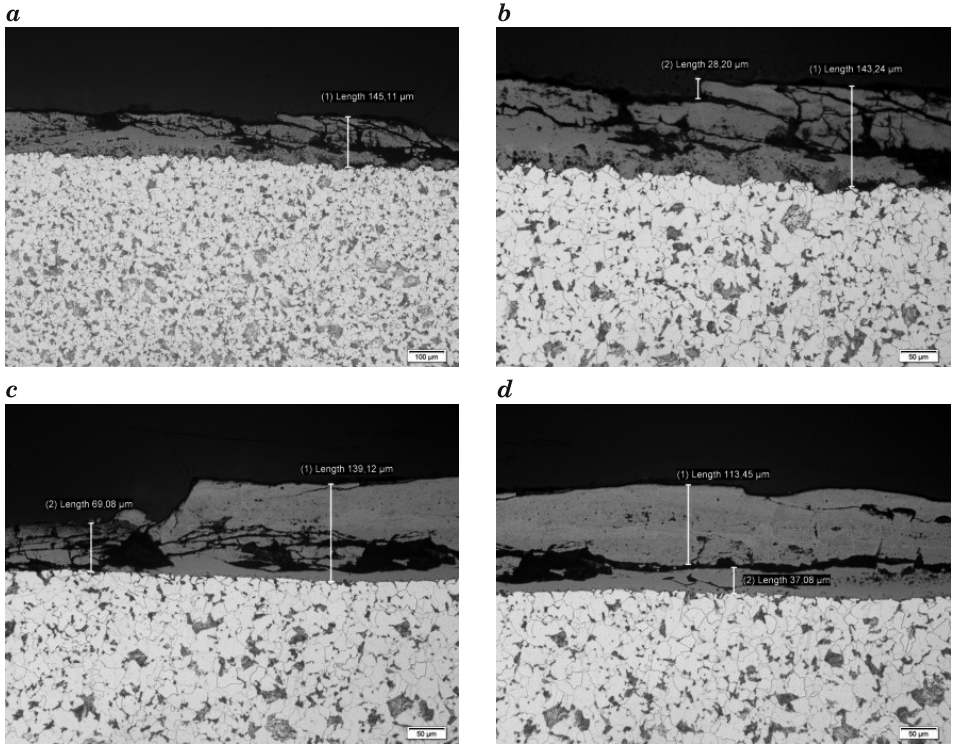
In the case of steel 1 (Fig. 8) the amount of defects in the formed layer is much smaller than for steel 2 (Fig. 9). The oxide layer formed on steel 1 shows local damage in the form of numerous cracks, which locally create a network on the entire layer cross-section (Fig. 8a, b). Large fissures originate in places and fine porosity exists locally. In turn steel 2 features a great degradation (Fig. 9). In some places the oxide layer is entirely separated from the substrate, which is shown in Fig. 9a. Also huge fissures occur, reaching the depth of  $70 \mu\text{m}$  (Fig. 9b). The oxide layer on steel 2 is mostly torn off and cracked (Fig. 9c). In addition, in steel 2 directly on the steel side there is major corrosion along grain boundaries, reaching the depth of  $15 \mu\text{m}$  (Fig. 10). Abang and others in paper (ABANG et al. 2011) showed that, under both operating conditions the surface layer was characterised by loosely attached formations of ash that were partially flaked. The outer layer of corrosion was covered with many tiny pores. Apart from the tiny pores under oxyfuel conditions, the inner layer of corrosion also had a few large pores.

Fig. 8. Defects of oxides layer existing on steel 1

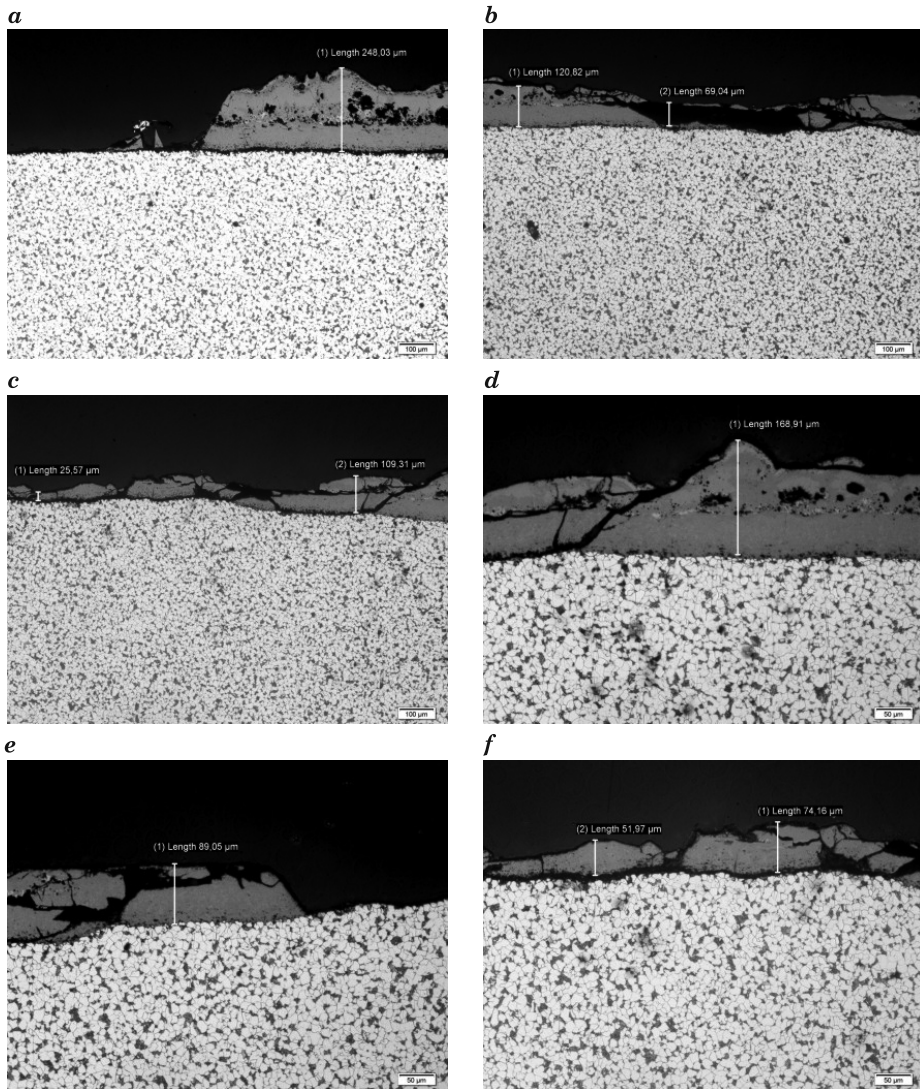
Fig. 9. Defects of oxides layer existing on steel 2

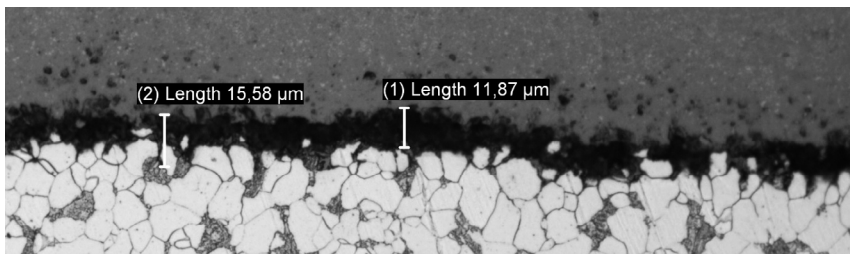
Fig. 10. Corrosion on the grain boundaries at the outside surface, 500x
