## **RENOVATION OF BUILDINGS AND MODERNIZATION OF BUILT-UP AREAS – A CASE STUDY**

***Barbara M. Deja***

Department of Civil Engineering and Building Structures  
University of Warmia and Mazury in Olsztyn

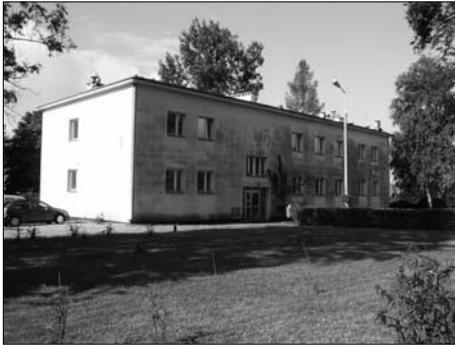
Fig. 1. The building of the Institute of Animal Reproduction and Food Studies, the Polish Academy of Sciences (PAN) in Olsztyn, the north-eastern angle, as of 2002. Photo: B. DEJA

At that time the Institute was seated in Bydgoska Street, in a building raised in the 1970s using traditional building technologies. It was a single-

module, two-storey building with a basement and a ventilated flat roof (Fig. 1). The technical state of the building was satisfactory, but the building was too small for the institute, which was growing in size, and it failed to meet the standards regarding facilities and aesthetic values. What was necessary then was to renovate and expand the building.

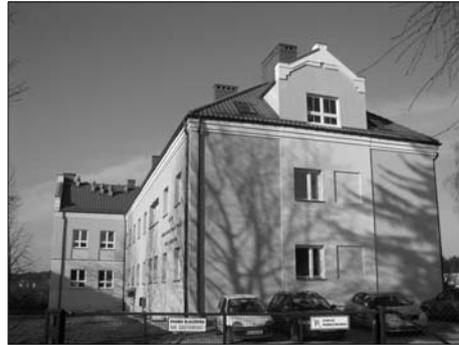
Fig. 2. The building of the Institute of Animal Reproduction and Food Studies, the Polish Academy of Sciences (PAN) in Olsztyn after the renovation and expansion. A view from the south-eastern angle. Photo: B. DEJA, 2008

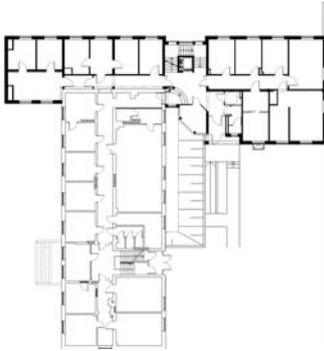
Fig. 4. The plan of the ground floor of the Institute of Animal Reproduction and Food Studies PAN in Olsztyn. Drawing: B. DEJA

The refurbished main building was designed as a three-storey building with a cellar and usable attic, built on an L-shaped plan (Fig. 4).

The interconnecting passages between the old and the new module of the building were designed on the ground floor and in the attic. In the newly added attic, the passage was included in the architectural design whereas in the existing ground floor it was made by changing one of the windows (seen in figure 4 in the top right-hand corner of the old building drawing) into a door.

The expansion of the building was carried out using the traditional construction technology and locally available building materials. The old building was covered with a gable purlin-rafter roof supported on bearing walls (Fig. 6). A similar roof (also tiled with Dutch roof tiles) was made on the new building. The roof was supported by lengthwise bearing walls and binding joists, which along with the supporting posts constitute a load bearing structure for the floors in the part of the new module adjacent to the side wall of the old building (Fig. 4).

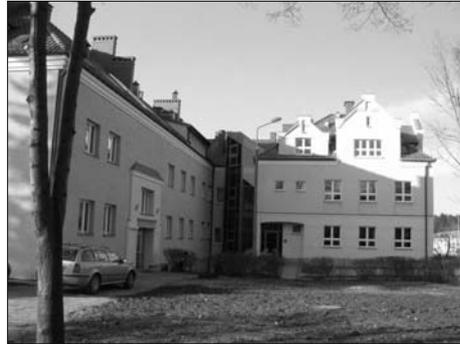
Fig. 5. A view of the new building of the PAN Institute in Bydgoska Street, the north-eastern side. Photo: B. DEJA, 2008

The former entrance facing busy Bydgoska Street was abandoned. Instead, the main entrance was placed in the north wall, which made the building easily accessible from the car park (Fig. 5).

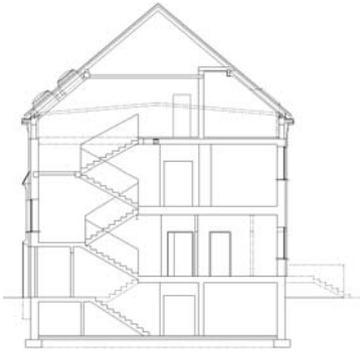
Fig. 6. A sectional view of the old building in Bydgoska Street. Visible are the existing flat roof and the new gable roof. Drawing: B. DEJA

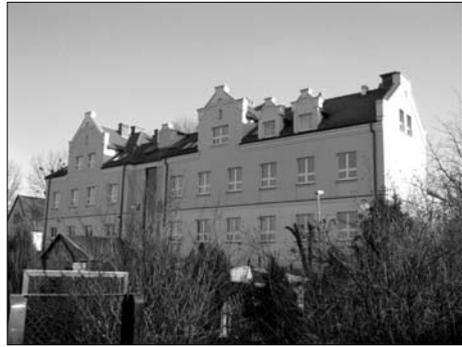
Fig. 7. A view of the new building of the PAN Institute in Bydgoska Street, the western side. Photo: B. DEJA, 2008

Special ramps and an outdoor lift for the disabled (also wheelchair users) were added to the building. While planning the whole building project, the works were divided into stages so that the existing building was never put out of use. In January 2008 the construction works were completed and in spring this year the landscaping works will begin, including a new car park, a new

drive and some new plants (Fig. 7). The renovation of the other two buildings<sup>3</sup> – the hotel and the animal house – will commence when the investor secures proper funds.

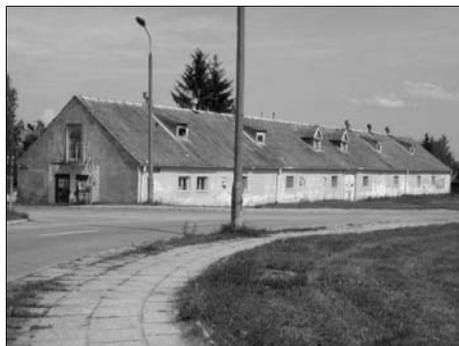
Fig. 12. The fodder storehouse at 46 Słoneczna Street as of 2001. Photo from the archives of the Real Estate Management Department of the UWM

The building underwent a technical evaluation, which showed that it was in very bad technical state. The unheated building, which had been used to store loose animal fodders, had very moist walls, attacked by fungus. Besides, the height of the ground floor was very low and certain construction limitations excluded a possibility to expand the building vertically, whereas the small size of the land parcel on which the building stood limited its horizontal expansion.

Figures 12 and 13 show the old fodder storehouse designated to be demolished and the building raised on the recovered land plot. The drastic decision made by the architect (and accepted by the investor) made it possible to raise a functional building, which serves the purposes of the users very well and is liked by the people living nearby. The modernization of the land plot to house the Centre improved the aesthetic quality of this part of the university campus.

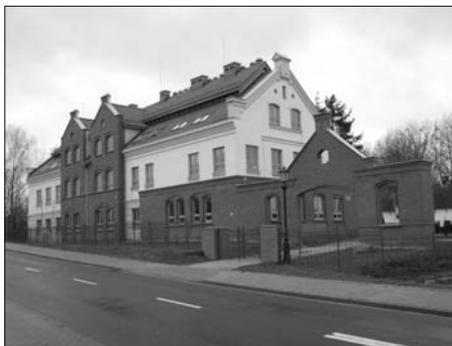
Fig. 13. A view of the Centre of Environmental Biotechnology from the south-eastern side. In the foreground, the fence, gate and part of the landscaped ground. Photo: B. DEJA, 2008
