## **STRUCTURE STUDIES OF POROUS OXIDE LAYERS FORMED ON 13CrMo4-5 STEELS LONG-TERM OPERATED IN THE POWER INDUSTRY**

***Monika Gwoździk***

The paper contains results of studies on the formation of oxide layers on 13CrMo4-5 steel long-term operated at an elevated temperature. The material studied comprised specimens of 13CrMo4-5 steel operated at the temperature of 455°C during 130,000 hours (steel 1) and 540°C during 120,000 hours (steel 2). The oxide layer was studied on a surface and a cross-section at the outer surface of the tube wall. The paper contains results of studies of porosity in the oxide layer. The oxide layer formed on the studied steel 1 is ~146 µm thick, while on the steel 2 ~248 µm. It has been found that steel 2 has higher porosity.

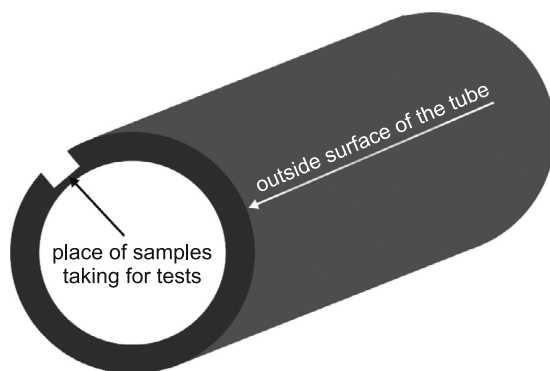
The oxide layer was studied on a surface and a cross-section at the outer surface of the tube wall (Fig. 1).

Fig. 1. Place of samples taking for tests
